TECHNICAL SERVICE BULLETIN

Technical Service Bulletin Number- TSB0011

Item, Unit or Assembly Affected- Some Shift-N-Step Units

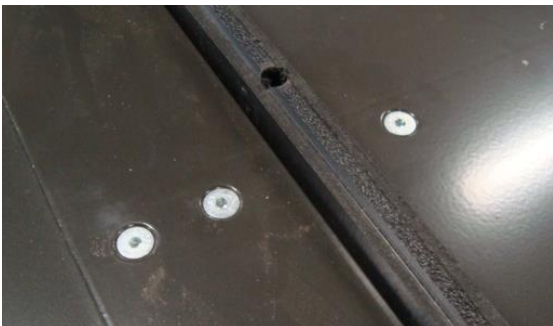
Reason for Bulletin- Possible Installation of incorrect rivet nuts into Shift-N-Step Base. Some Shift-N-Step units were assembled using the incorrect rivet nuts. Before installing any Shift-N-Step unit, carefully inspect the bottom side. There are 38, ¼-20 Flat Head Socket Cap Screws that attach the Top Plate to the Base Assembly (typical as shown below).

The Base Assembly contains 38 corresponding rivet nuts. If the incorrect rivet nut was installed, there is a possibility that the bolt could extract the rivet nut out of the bottom plate, resulting in a failed connection.

Action Required- DO NOT INSTALL ANY SHIFT-N-STEP UNIT UNTIL CHECKED FOR THIS DEFECT. Carefully inspect the bottom side of the Shift-N-Step Base at ALL 38 locations.

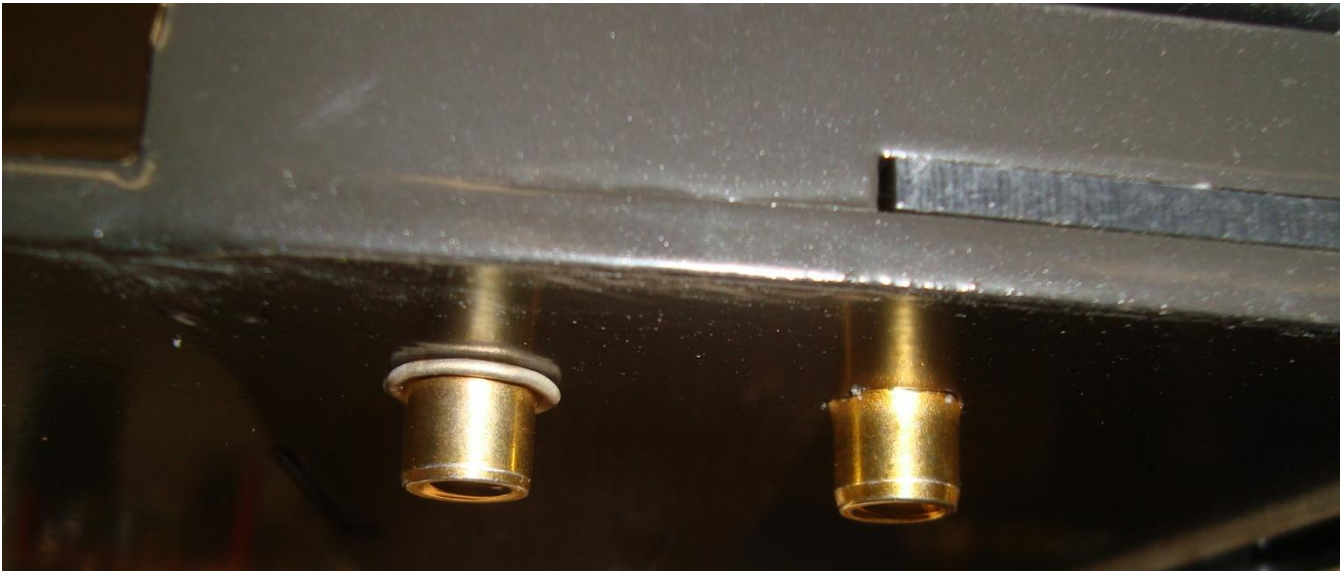
The correct rivet nuts will show an obvious “ring” at the underside of the plate where the riveting expansion process (“mushroom”) has occurred (as shown on the left side in the photo below). This is correct and normal. If there is NO “ring” (mushrooming) visible, this indicates an INCORRECT rivet nut at that location (as shown on the right side in the photo below).

If even just one of these incorrect rivet nuts has occurred on the Base, **DO NOT INSTALL THE SHIFT-N-STEP and DO NOT attempt a repair. Contact AbiliTrax Immediately. The defective units MUST BE returned for repair by AbiliTrax ONLY.**

A replacement unit will be provided as soon as possible.
