## TECHNICAL SERVICE BULLETIN

**Technical Service Bulletin Number-TSB0015 – Shift-N-Step Shortened Rack**

**Item, Unit or Assembly Affected – Shift-N-Step (Drive Ski)**

**Unit(s) Affected – SNS5770356—SNS5770481**

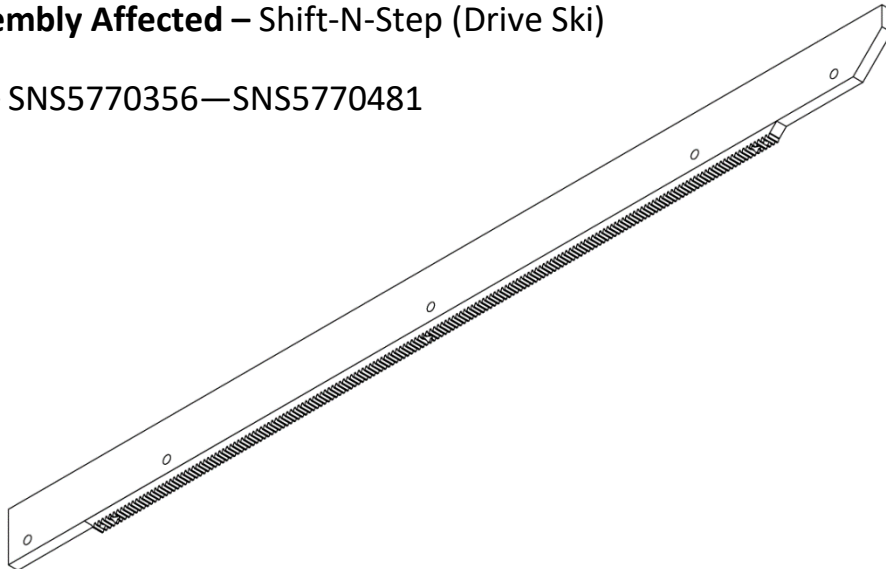
**Reason for Bulletin –** Affected Shift-N-Step units will look and operate normally, but have a shortened range of teeth on the rack of the drive ski. To determine if this affects your unit, operate the Shift-N-Step to put the lift in the full right (lift operation) position. Then, look into the channel where the emergency back-up/manual operation tool is inserted and determine if the rack teeth extend far enough to the left for the tool to work properly. Replacement skis may be ordered free of charge directly from [mary@abilitrax.com](mailto:mary@abilitrax.com). Labor reimbursement claims are be made by contacting [ap@fentonmobility.com](mailto:ap@fentonmobility.com). Labor allowance will be at a rate of 3 hrs @ \$90.00 per hour

The drive ski must be **replaced**.

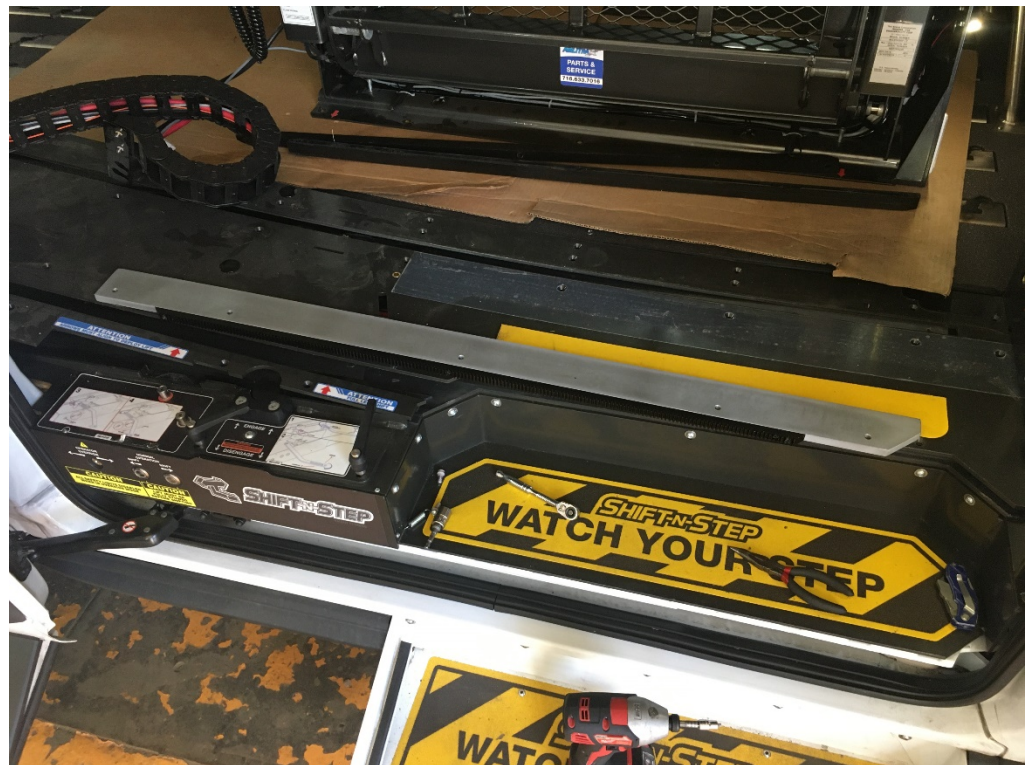
Now, with the lift out of the way, **remove** the ski stand-off from the drive ski/front track. Then, use the 5/32" Allen bit to **remove** the 4 bolts holding down the slide plate, and needle-nose pliers to **release** the springs. Now use the 5/32" Allen bit with an impact driver to **remove** the 38 bolts holding the top plate down. A knife or razor will be needed to **cut** 4 holes in the slide tape that covers some Allen bolts. One is located beneath the "ATTENTION: FULL SHIFT LEFT" sticker.

At this point, it is possible to **peel** up the lift plate and remove the drive ski from the Shift-N-Step unit. It may be necessary to **remove** the plastic covers on the B-pillar. It is a good idea to **take** some pictures before disturbing the layers, this will make re-assembly easier. There is also a diagram provided in this document. At this point, the ski can be **removed**. **Insert** the replacement ski between the Nylatron strips, using caution not to damage them.

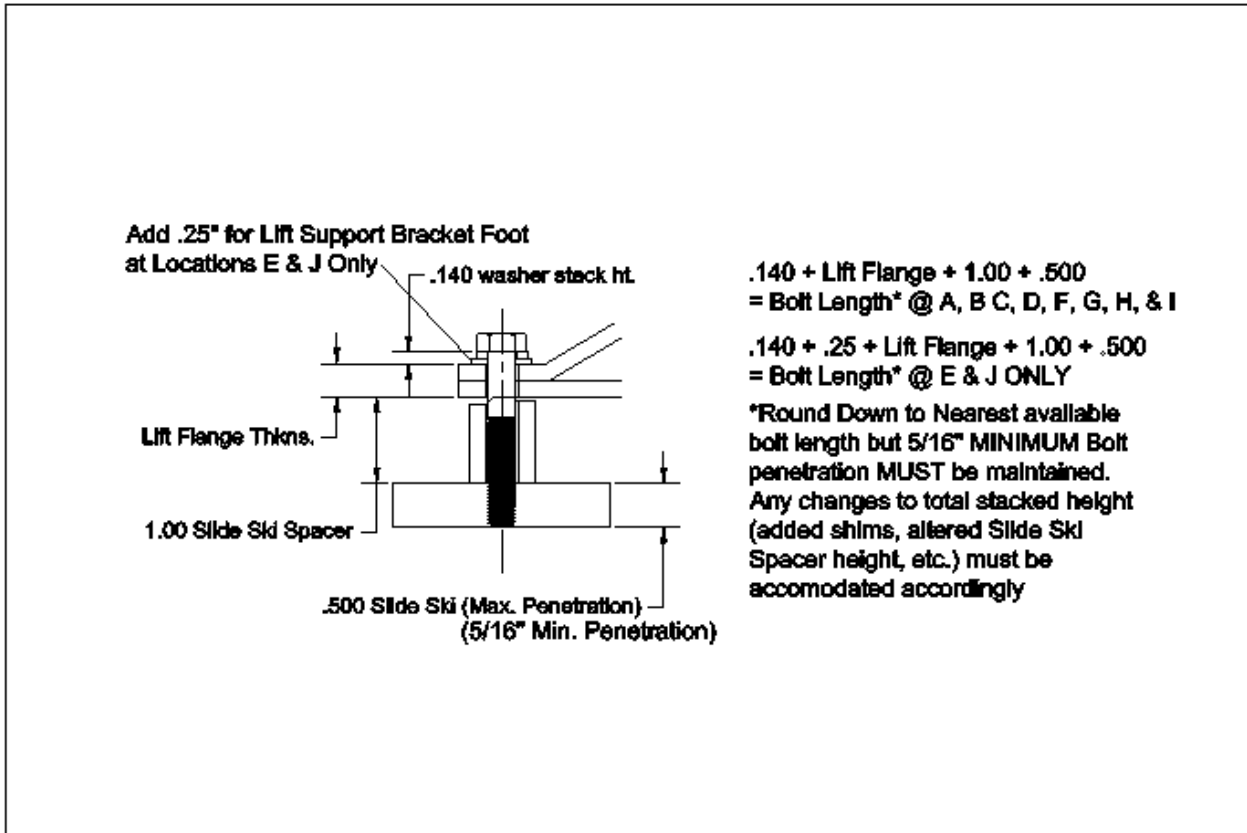
## Bolt Length Requirements for Mounting Braun or Ricon Lift to Shift-N-Step

Using the proper length bolts to attach a Braun or Ricon Lift to the Shift-N-Step Unit is critical. Required bolt lengths will vary depending on Lift Manufacturer and Bolt location. Using Bolts that are too long may result in bolts protruding beyond the face of the Slide Skis. This will cause the Skis to “drag” in the channels and will cause the Shift-N-Step to bind or jam. Protruding bolts will also damage the Ski bearing surfaces. Bolts must also penetrate at least 5/16” into the Slide Skis to assure adequate lift retention.

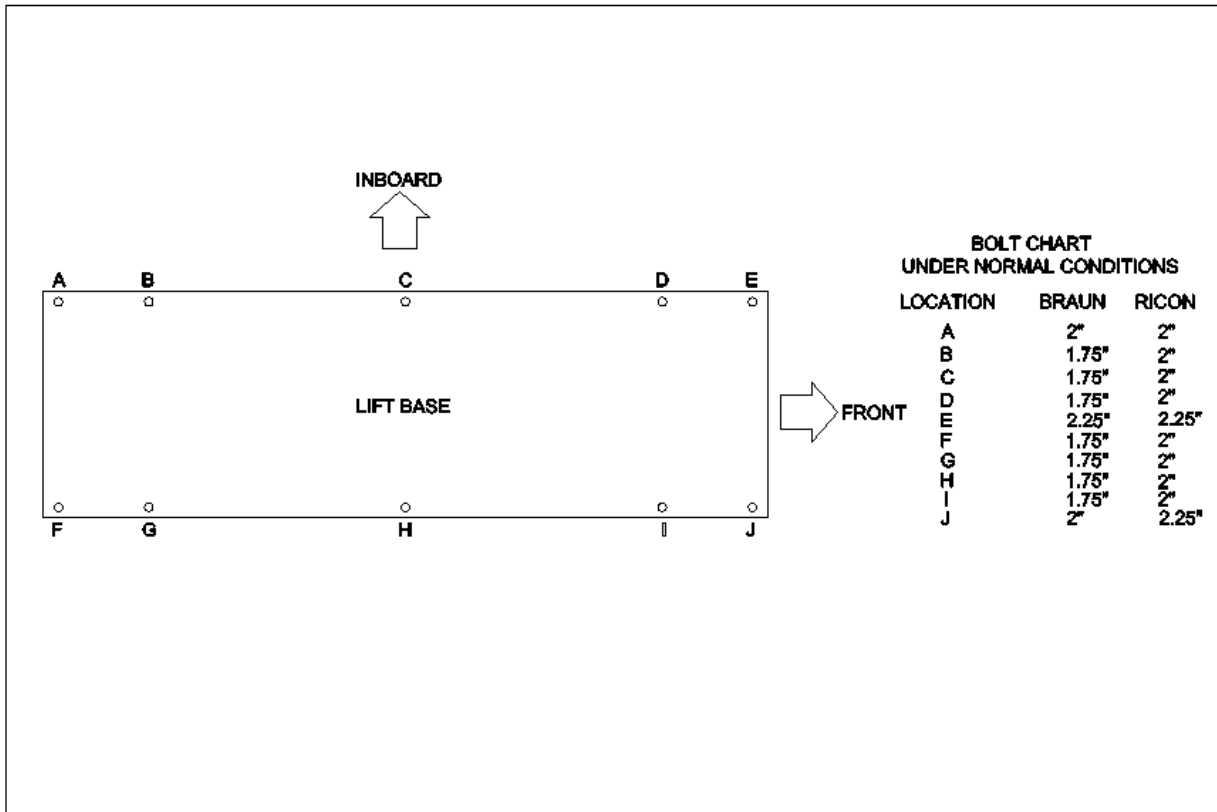
Please refer to the chart below for “normal” conditions. Keep in mind that adding to the total “stacked height” (added shims, etc.) may result in inadequate bolt penetration into the Slide Skis (5/16” MINIMUM) and reducing the total “stacked height” (reduced Slide Ski Spacer height, etc.) may result in bolts that are too long. Any changes in total “Stacked Height” will require recalculations of bolt lengths accordingly
